PRELIMINARY ASSESSMENT REPORT

Lake Conestee Greenville, Greenville County, South Carolina

Oneida Total Integrated Enterprises (OTIE)
1220 Kennestone Circle, Suite 106
Marietta, Georgia 30066

Contract No. : EP-S4-15-01
TDD No. : 0005/OT-05-031
Date Submitted : August 15, 2019
EPA Task Monitor : Jeff Crowley
Telephone No. : 404-562-9587
Prepared by : Stacy Kowalski
Telephone No. : 770-366-6751

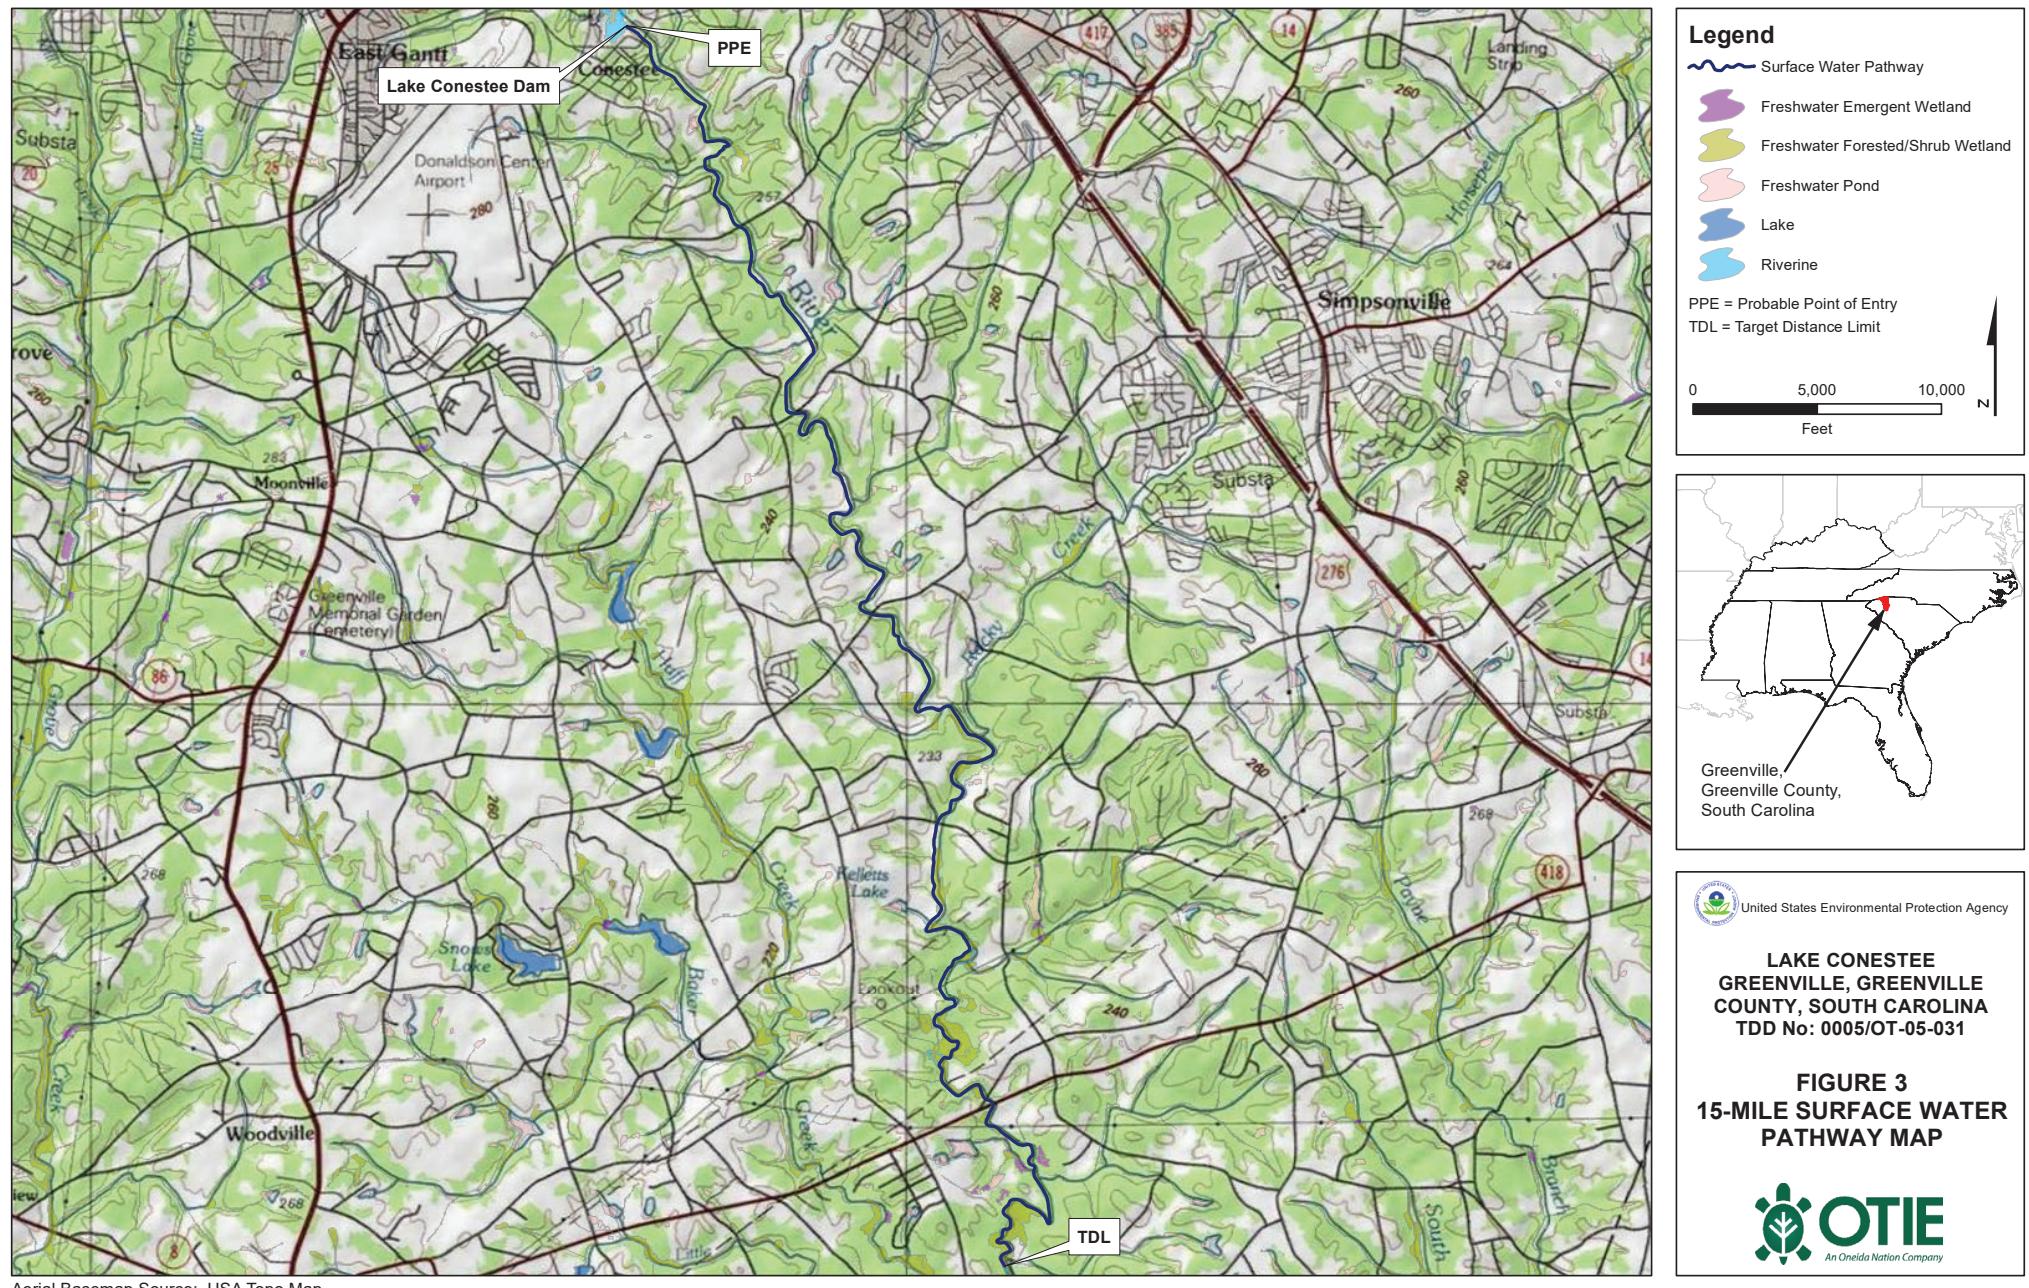
The surface water pathway begins at the LCD [Probable Point of Entry (PPE) 1] and continues into the Reedy River. The Reedy River flows in a generally southeasterly direction. The surface water pathway ends at the 15-mile target distance limit (TDL) within the Reedy River, just south of SC Highway 418 (see Figure 3). Greenwood Lake, the municipal water supply, is located approximately 53 miles downstream of LCD.

No state or federally listed threatened or endangered species are known to occur within the Lake Conestee site. The South Carolina Threatened and Endangered Species Inventory has recorded no listed species within a 5-mile radius of the site (Ref. 7, p. 19). Wetland frontage totaling approximately 27 miles is present along both sides of the 15-mile TDL of the site (see Figure 3).
